## **Historic Structure Assessment for Building 839, Carlisle Barracks**

Carlisle, Pennsylvania

October 2017

Final report

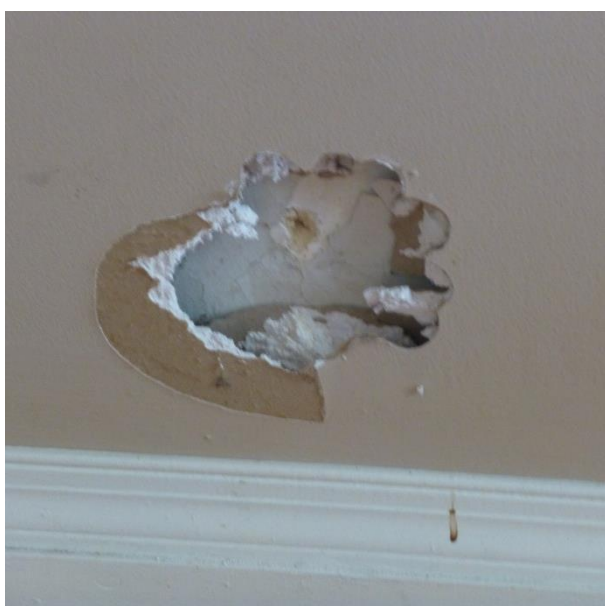
Overall, the wall finishes are in fair condition. However, both units have extensive paint failure throughout and some localized damage in locations where previous invasive materials testing was conducted. The wall damage in Rooms 304 and 305 was caused by vandalism.

Damaged drywall walls in Room 304 in Unit A.  
(Photo: CERL, 5/2/17)

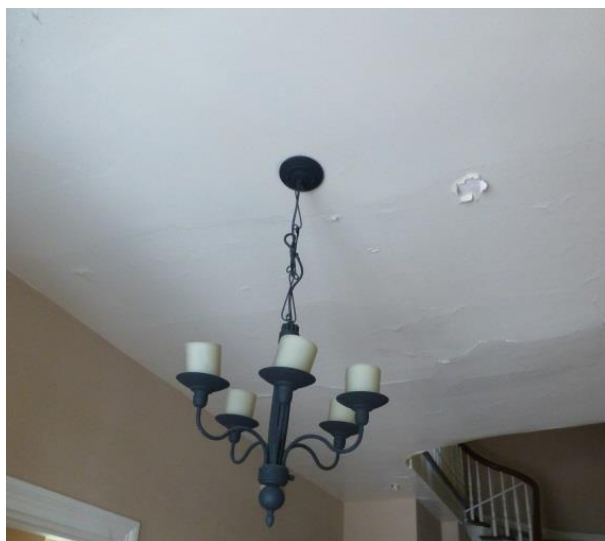
Painted plaster ceiling in Room 101.  
(Photo: CERL, 5/2/17)

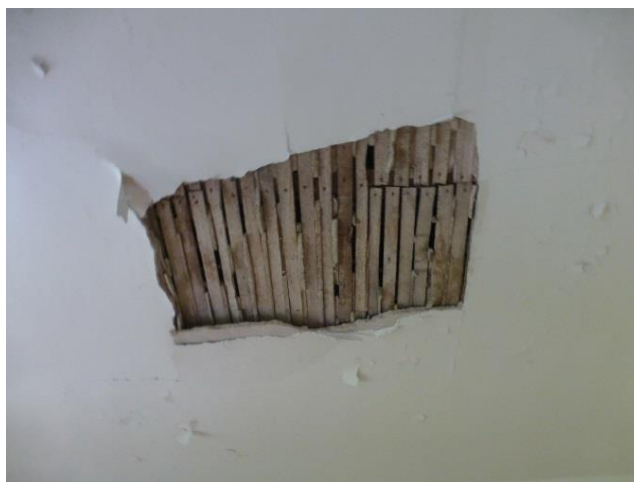
The ceilings in Rooms 108, 109, 110, 203, 204, 205, and 207 in Unit B are painted plaster in fair condition with some paint failure and minor cracking. An approximately 2'-0" x 3'-0" area of plaster has been removed from the Room 110 ceiling. Rooms 111 and 206 have painted drywall ceilings in good condition. Rooms 107 and 109 have painted beaded board ceiling finishes in fair to poor condition, with water damage at the exterior wall. Room 108 has a painted beaded board ceiling in fair condition. The exterior second-floor storage space on the east balcony has an unpainted beaded board ceiling finish in fair condition.

Exposed lath in the ceiling of Room 110.  
(Photo: CERL, 5/2/17)

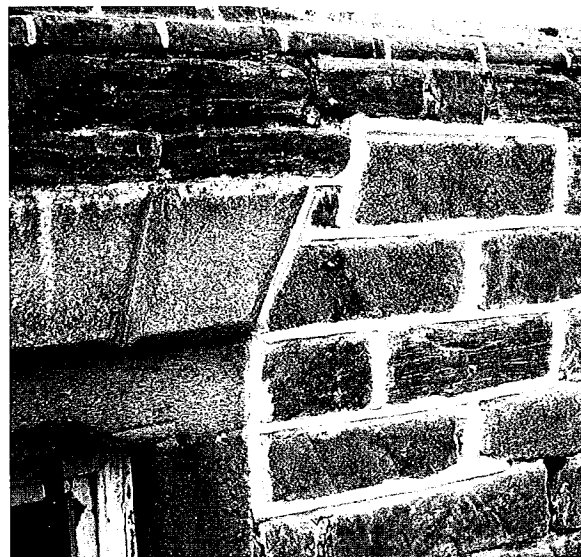
Figure 4. (left) The poor quality of this repointing—it appears to have been “tooled” with the mason’s finger—does not match the delicacy of the original beaded joint on this 19th-century brick wall. (right) It is obvious that the repointing on this “test patch” is not an appropriate replacement mortar joint for this early-19th century stone foundation. Photos: Lee H. Nelson, FAIA.

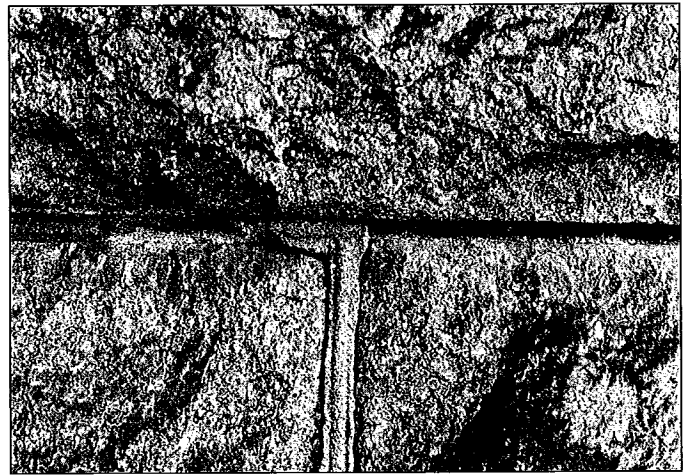
*Figure 8. Due to inadequate joint preparation, the repointing mortar has not adhered properly and is falling out of the joint. Photo: Robert C. Mack, FAIA.*

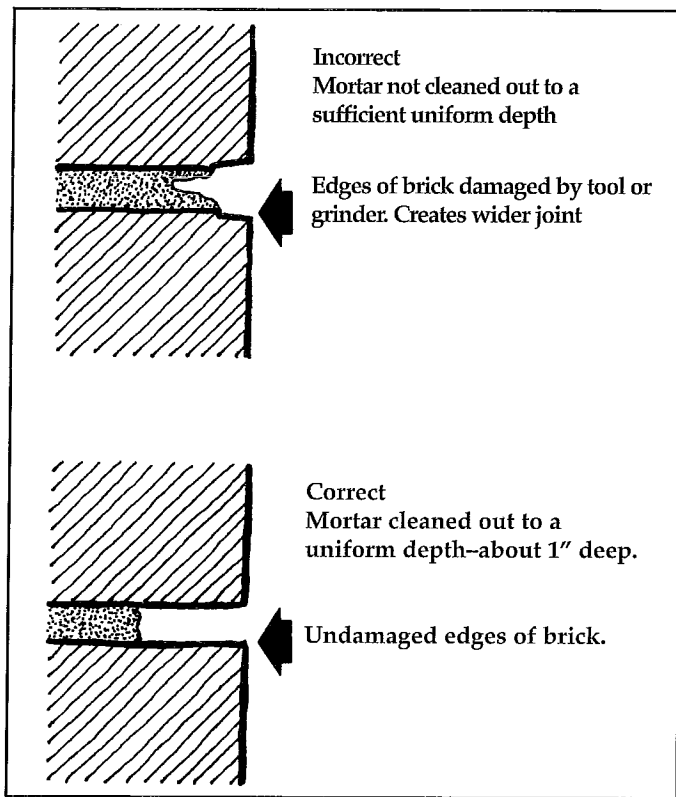
Figure 9. Comparison of incorrect and correct preparation of mortar joints for repointing. Drawing: Robert C. Mack, FAIA, and David W. Look, AIA.

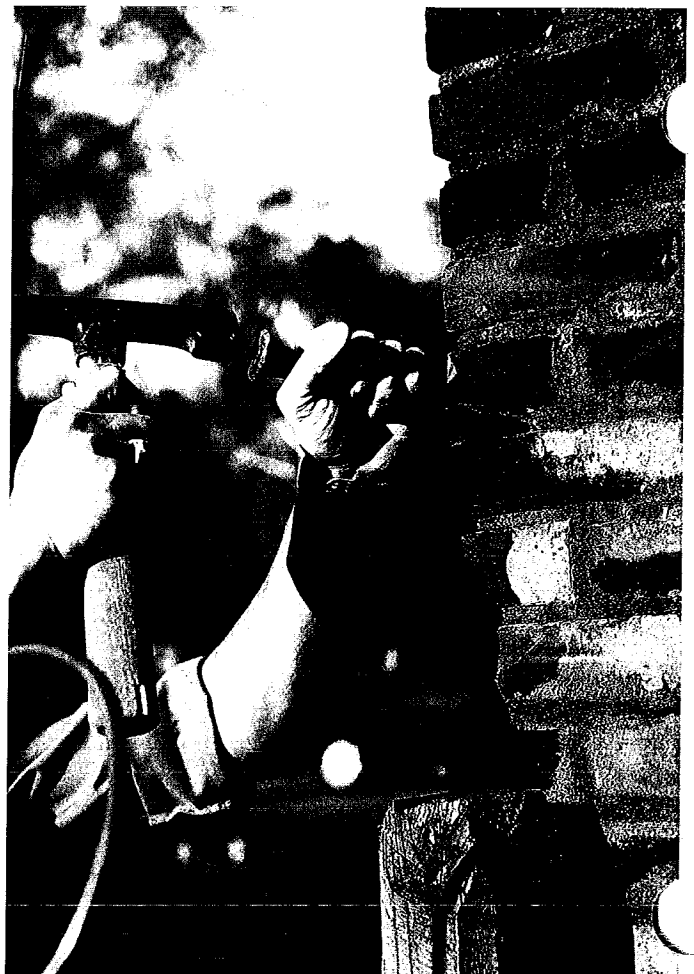
Figure 10. Using a hammer and masonry chisel is the least damaging and, thus, generally the preferred method of removing old mortar in preparation for repointing historic masonry. Photo: John P. Speweik.

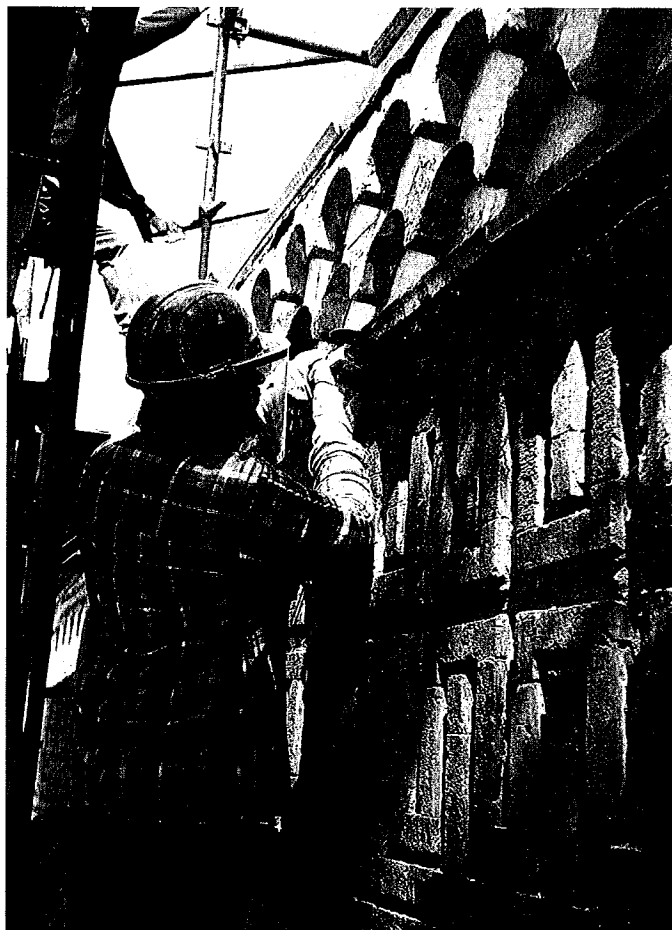
Figure 12.. A power grinder, operated correctly by a skilled mason may be used in preparation for repointing to cut wide, horizontal mortar joints, typical of many early-20th century brick structures without causing damage to the brick. Note the use of protective safety equipment. Photo: Robert C. Mack, FAIA.

Under certain circumstances, thin diamond-bladed grinders may be used to cut out *horizontal* joints only on hard portland cement mortar common to most early-20th century masonry buildings (Fig. 12). Usually, automatic tools most successfully remove old mortar without damaging the masonry units when they are used in combination with hand tools in preparation for repointing. Where horizontal joints are uniform and fairly wide, it may be possible to use a power masonry saw to assist the removal of mortar, such as by cutting along the middle of the joint; final mortar removal from the sides of the joints still should be done with a hand chisel and hammer. Caulking cutters with diamond blades can sometimes be used successfully to cut out joints without damaging the masonry. Caulking cutters are slow; they do not rotate, but vibrate at very high speeds, thus minimizing the possibility of damage to masonry units (Fig. 13). Although mechanical tools may be used safely in limited circumstances to cut out horizontal joints in preparation for repointing, they should never be used on vertical joints because of the danger of slipping and cutting into the brick above or below the vertical joint. Using power tools to remove mortar without damaging the surrounding masonry units also necessitates highly skilled masons experienced in working on historic masonry buildings. Contractors

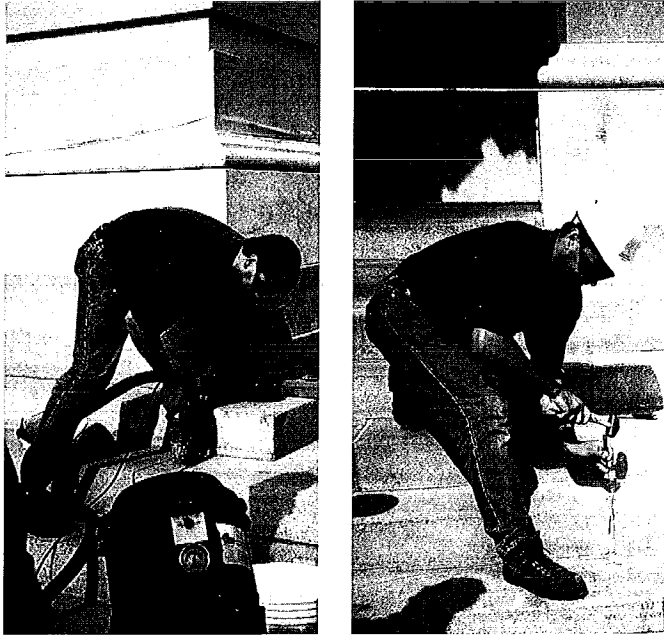
Figure 13. (left) In preparation for repointing, the mortar joints on these granite steps are first cut out mechanically (note the vacuum attached to the cutting tool in foreground to cut down on dust). (right) Final removal of the old mortar is done by hand to avoid damage to the edges of the joints. Mechanical preparation of horizontal joints by an experienced mason may sometimes be acceptable, especially where the joints are quite wide and the masonry is a very hard stone. Photos: Anne Grimmer.

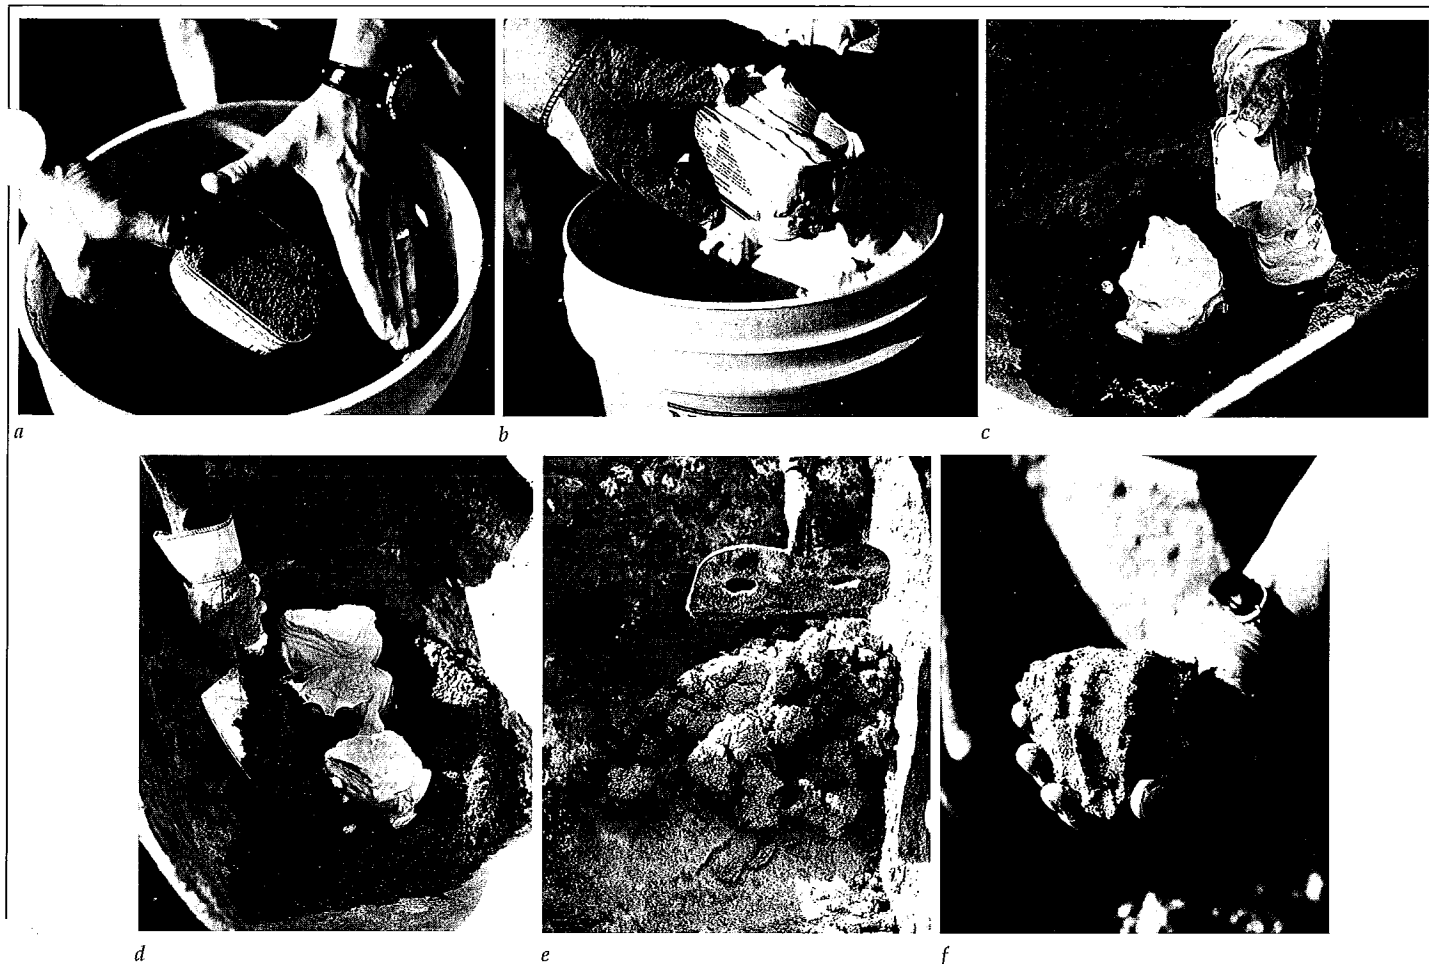
Figure 14. Mixing mortar using lime putty: (a) proportioning sand; (b) proportioning lime putty; (c) placing lime putty on top of sand; (d) mixing sand over lime putty; (e) hand mixing mortar; and, (f) sample of mortar after mixing. Photos: John P. Speweik.

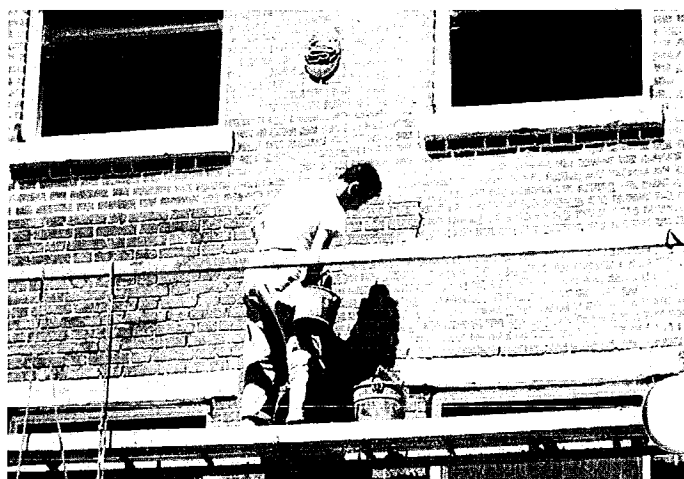
Figure 17. This photograph shows the significant visual change to the character of this historic brick building that has resulted from improper repointing procedures and a noticeably increased thickness of the mortar joints. Photo: Lee H. Nelson, FAIA.

A good repointing job is meant to last, at least 30 years, and preferably 50-100 years. Shortcuts and poor craftsmanship result not only in diminishing the historic character of a building, but also in a job that looks bad, and will require future repointing sooner than if the work had been done correctly (Fig. 17). The mortar joint in a historic masonry building has often been called a wall's "first line of defense." Good repointing practices guarantee the long life of the mortar joint, the wall, and the historic structure. Although careful maintenance will help preserve the freshly repointed mortar joints, it is important to remember that mortar joints are intended to be sacrificial and will probably require repointing some time in the future. Nevertheless, if the historic mortar joints proved durable for many years, then careful repointing should have an equally long life, ultimately contributing to the preservation of the entire building.

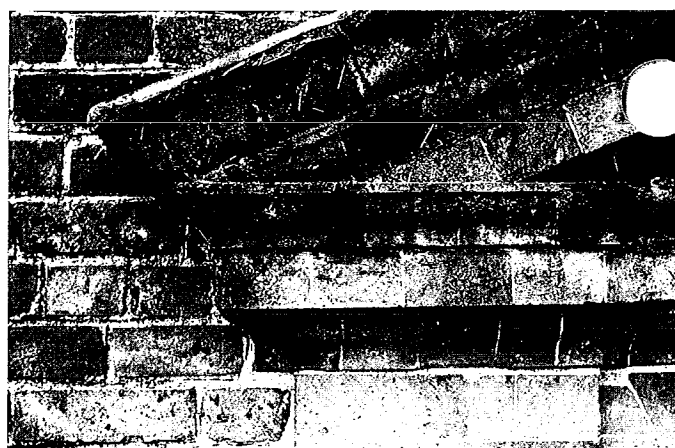
Figure 19. Mortar joints of 18th century brick buildings were often as much as 1/2 inch wide, cut flush and struck with a grapevine joint, but for window and door surrounds where a finer quality rubbed brick was used, mortar joints were very thin. Photo: National Park Service Files.

**Pointing Style.** Close examination of the historic masonry wall and the techniques used in the original construction will assist in maintaining the visual qualities of the building (Fig. 18). Pointing styles and the methods of producing them should be examined. It is important to look at both the horizontal and the vertical joints to determine the order in which they were tooled and whether they were the same style. Some late-19th and early-20th century buildings, for example, have horizontal joints that were raked back while the vertical joints were finished flush and stained to match the bricks, thus creating the illusion of horizontal bands. Pointing styles may also differ from one facade to another; front walls often received greater attention to mortar detailing than side and rear walls (Fig. 19). **Tuckpointing** is not true repointing but the

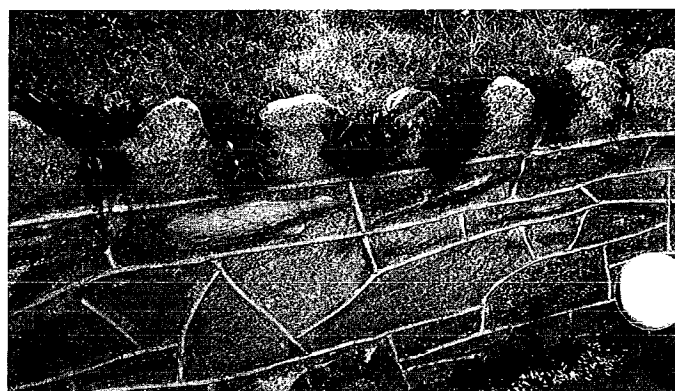
Figure 20. This stone garden wall was tuckpointed to match the tuckpointing on the c. 1920s house on the property. Photo: Anne Grimmer.

application of a raised joint or lime putty joint on top of flush mortar joints (Fig. 20). **Pencil**ing is a purely decorative, painted surface treatment over a mortar joint, often in a contrasting color.

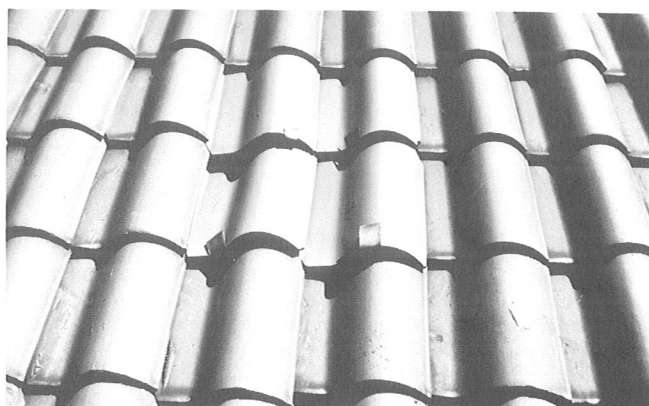
*Repairs on this pantile roof were made with new tiles held in place with metal hangers. (Main Building, Ellis Island, New York)*

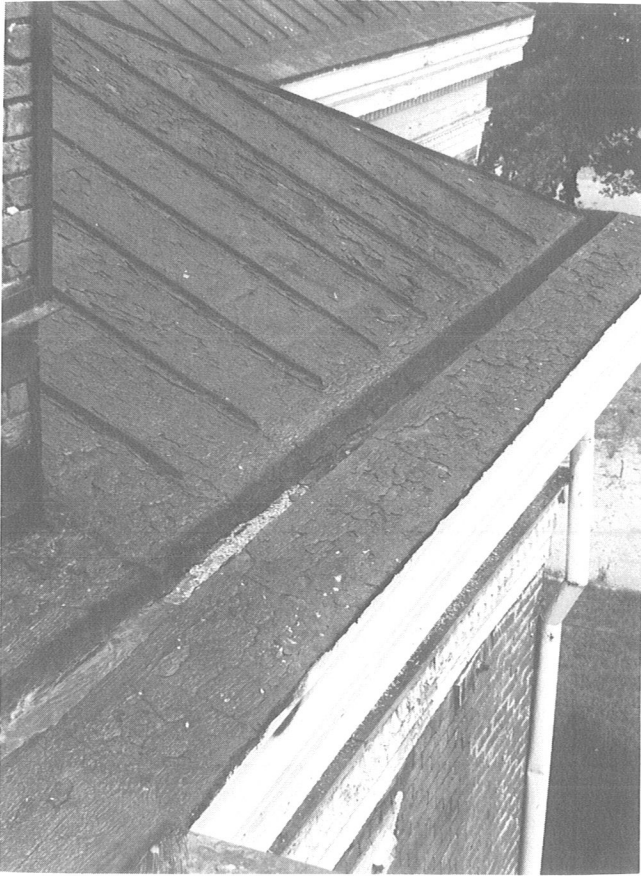
*Repeated repair with asphalt, which cracks as it hardens, has created a blistered surface on this sheet-metal roof and built-in gutter, which will retain water. Repairs could be made by carefully heating and scraping the surface clean, repairing the holes in the metal with a flexible mastic compound or a metal patch, and coating the surface with a fibre paint. (Roane County Courthouse, Kingston, Tennessee, photo courtesy of Building Conservation Technology, Inc.)*

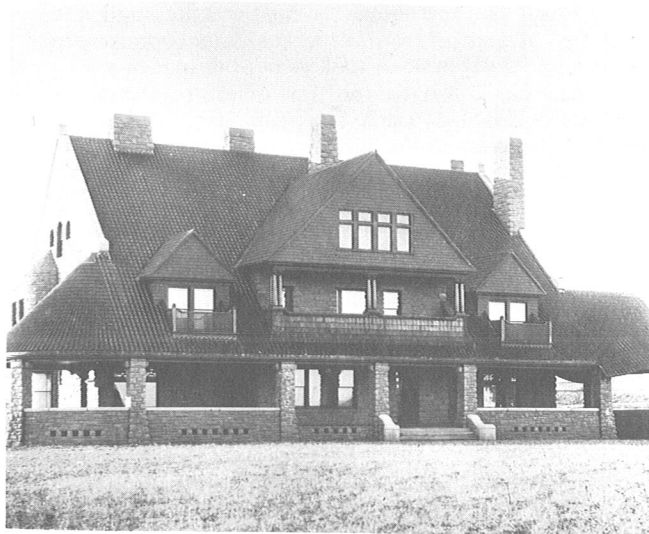
*These two views of the same house demonstrate how the use of a substitute material can drastically affect the overall character of a structure. The textural interest of the original tile roof was lost with the use of asphalt shingles. Recent preservation efforts are replacing the tile roof. (Frank House, Kearney, Nebraska, photo courtesy of the Nebraska State Historical Society, Lincoln, Nebraska)*

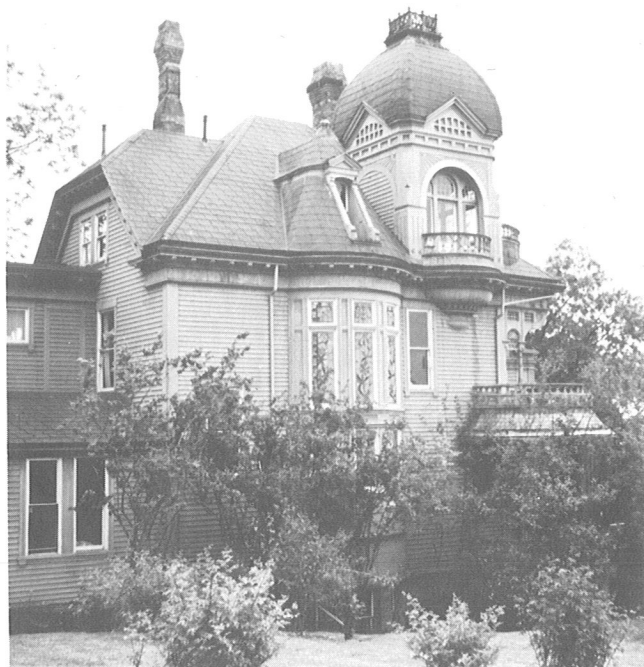
*Special problems inherent in the design of an elaborate historic roof can be controlled through the use of good materials and regular maintenance. The shape and detailing are essential elements of the building's historic character, and should not be modified, despite the use of alternative surface materials. (Gamwell House, Bellingham, Washington)*

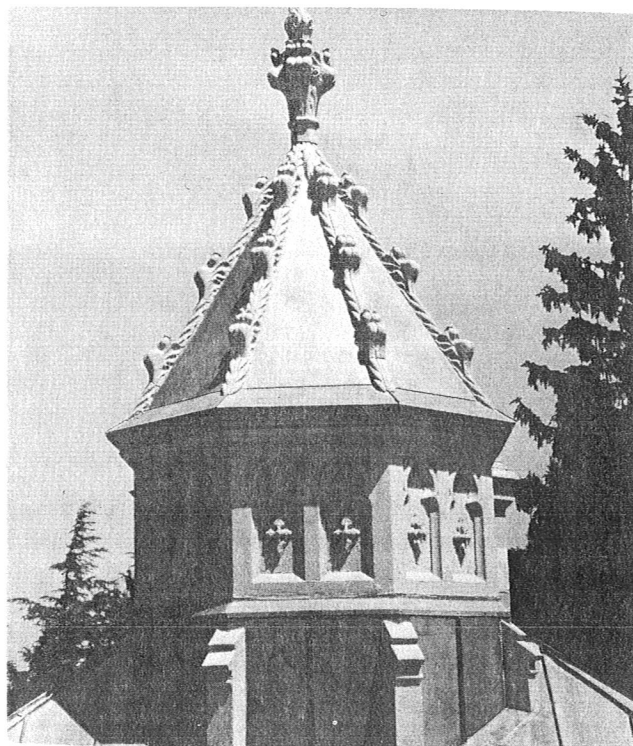
Decorative features such as cupolas require extra maintenance. The flashing is carefully detailed to promote run-off, and the wooden ribbing must be kept well-painted. This roof surface, which was originally tin plate, has been replaced with lead-coated copper for maintenance purposes. (Lyndhurst, Tarrytown, New York, photo courtesy of the National Trust for Historic Preservation)

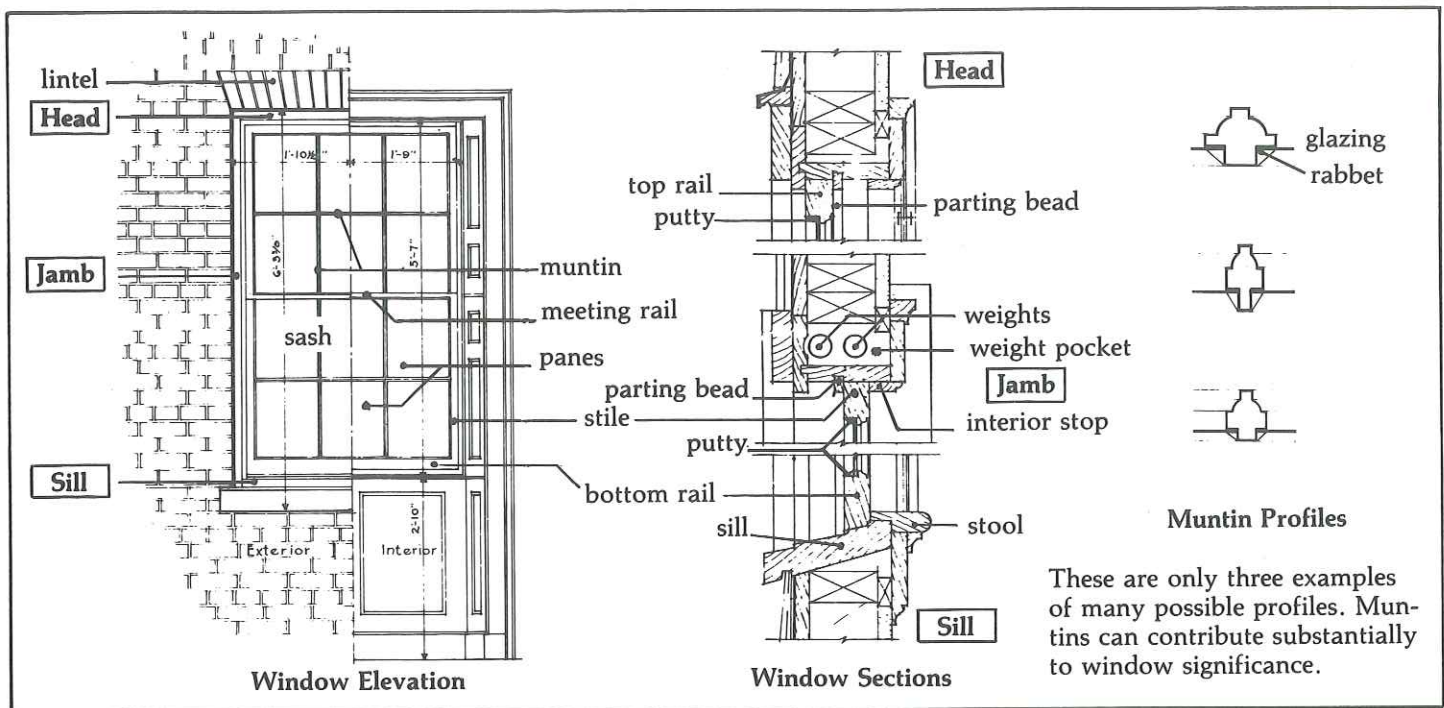
Figure 2. These drawings of window details identify major components, terminology, and installation details for a wooden double-hung window.

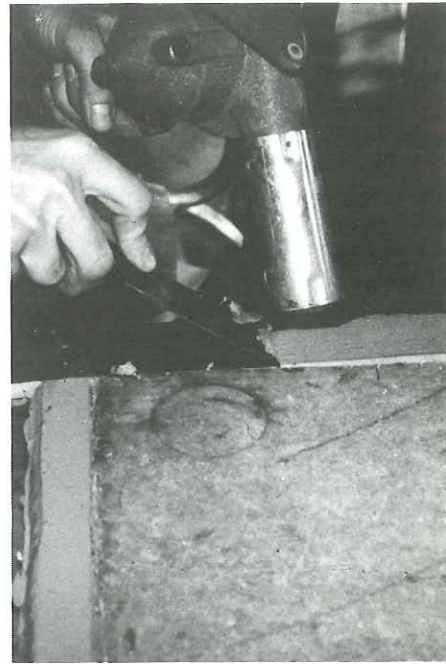
Figure 4c. Sash can be removed and repaired in a convenient work area. Paint is being removed from this sash with a hot air gun while an asbestos sheet protects the glass from sudden temperature change. Photo: John H. Myers

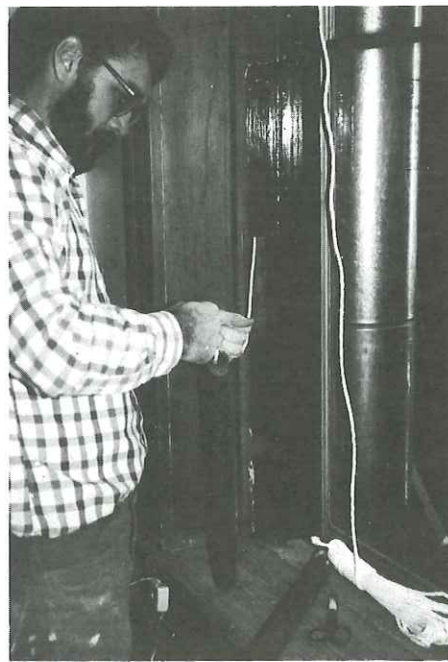
Figure 4e. A common repair is the replacement of broken sash cords with new cords (shown) or with chains. The weight pocket is often accessible through a removable plate in the jamb, or by removing the interior trim. Photo: John H. Myers

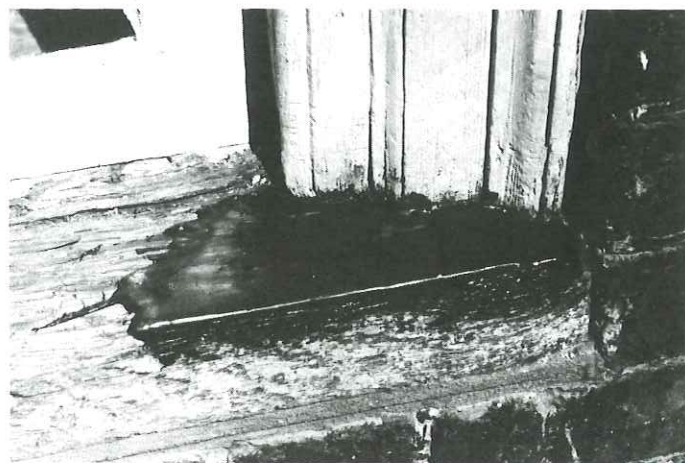
Figure 5. This illustrates a two-part epoxy patching compound used to fill the surface of a weathered sill and rebuild the missing edge. When the epoxy cures, it can be sanded smooth and painted to achieve a durable and waterproof repair. Photo: John H. Myers

Wood may also be strengthened and stabilized by consolidation, using semi-rigid epoxies which saturate the porous decayed wood and then harden. The surface of the consolidated wood can then be filled with a semi-rigid epoxy patching compound, sanded and painted (see figure 5). Epoxy patching compounds can be used to build up

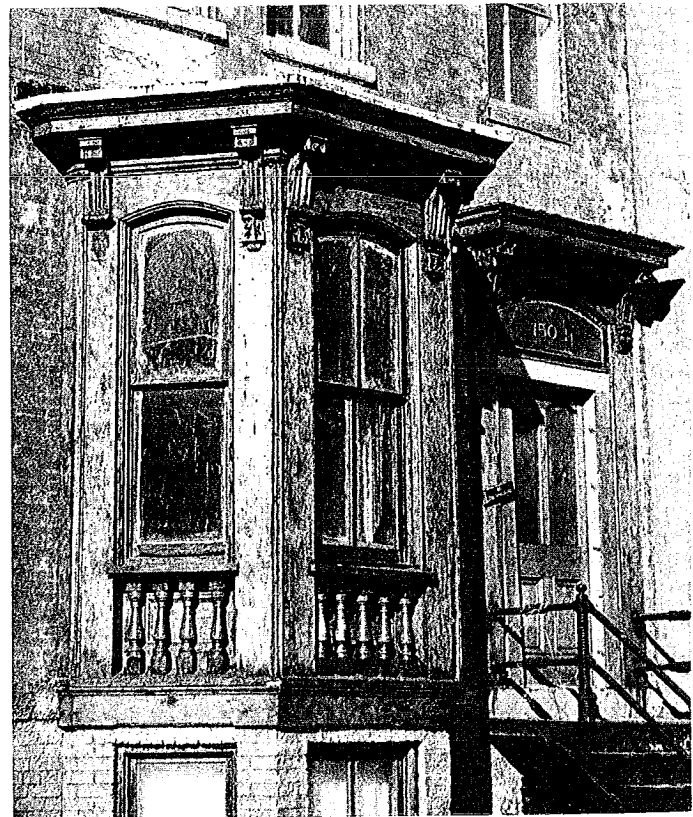
Fig. 2 A traditionally painted bay window has been stripped to bare wood, then varnished. In addition to being historically inaccurate, the varnish will break down faster as a result of the sun's ultraviolet rays than would primer and finish coats of paint. Photo: David W. Look, AIA.

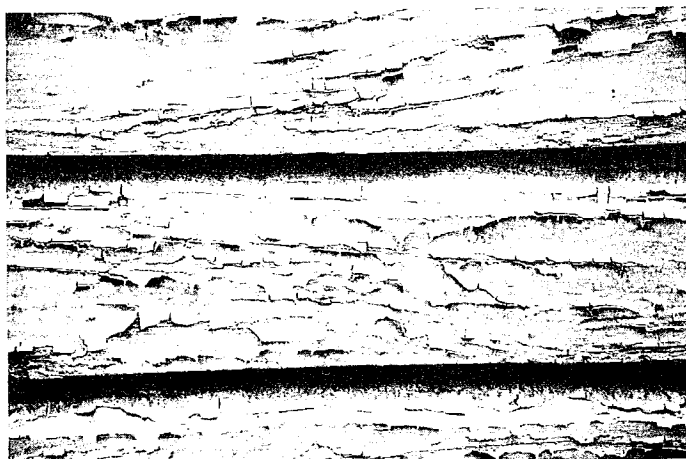
Fig. 9 Cracking, alligatoring, and flaking are evidence of long-term neglect of painted surfaces. The remaining paint on the clapboard shown here can be removed with an electric heat plate and wide-bladed scraper. In addition, unsound wood should be replaced and moisture problems corrected before primer and top coats of paint are applied. Photo: David W. Look, AIA.

If cracking and alligatoring are present only in the top layers they can probably be scraped, hand or mechanically sanded to the next sound layer, then repainted. However, if cracking and/or alligatoring have progressed to

bare wood and the paint has begun to flake, it will need to be totally removed. Methods include scraping or paint removal with the electric heat plate, electric heat gun, or chemical strippers, depending on the particular area involved. Bare wood should be primed within 48 hours, then repainted.

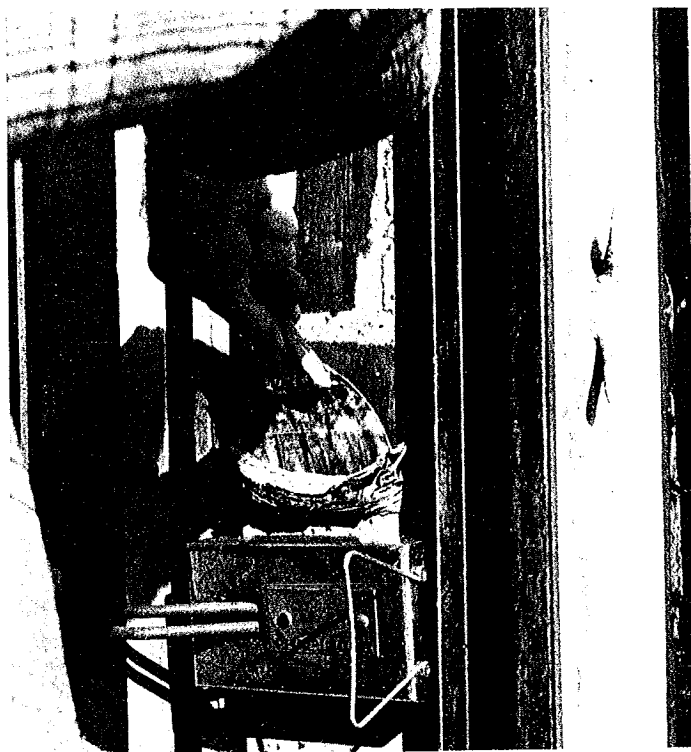
Fig. 13 The electric heat plate (with paint scraper) is particularly useful for removing paint down to bare wood on flat surfaces such as doors, window frames, and siding. After scraping, some light sanding will probably be necessary to smooth the surface prior to application of primer and top coats. Photo: David W. Look, AIA.

**Electric heat plate:** The electric heat plate (see figure 13) operates between 500 and 800 degrees Fahrenheit (not hot enough to vaporize lead paint), using about 15 amps of power. The plate is held close to the painted exterior surface until the layers of paint begin to soften and blister, then moved to an adjacent location on the wood while the softened paint is scraped off with a putty knife (it should be noted that the heat plate is most successful when the paint is very thick!). With practice, the operator can successfully move the heat plate evenly across a flat surface such as wooden siding or a window sill or door in a continuous motion, thus lessening the risk of scorching the wood in an attempt to reheat the edge of the paint sufficiently for effective removal. Since the electric heat plate's coil is “red hot,” extreme caution should be taken to avoid igniting clothing or burning the skin. If an extension cord is used, it should be a heavy-duty cord (with 3-prong grounded plugs). A heat plate could overload a circuit or, even worse, cause an electrical fire; therefore, it is recommended that this implement be used with a single circuit and that a fire extinguisher always be kept close at hand.

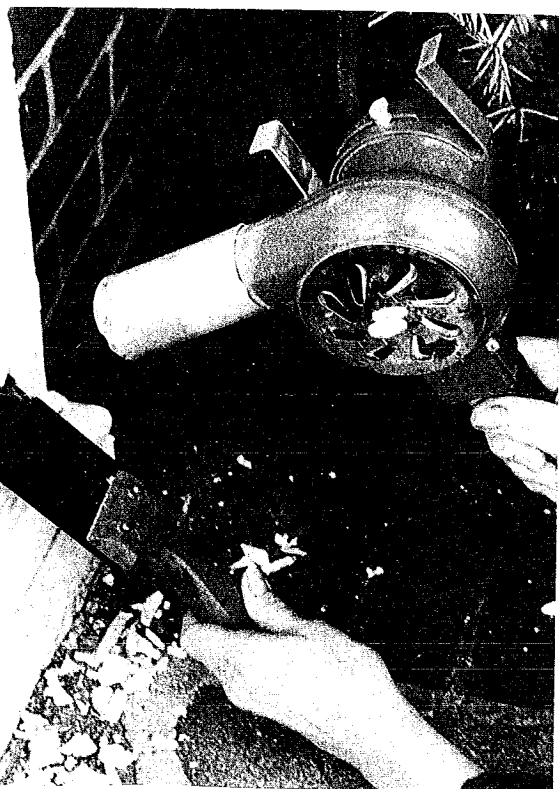
Fig. 14 The nozzle on the electric heat gun permits hot air to be aimed into cavities on solid decorative elements such as this applied column. After the paint has been sufficiently softened, it can be removed with a profiled scraper. Photo: Charles E. Fisher, III.

Although the heat gun is heavier and more tiring to use than the heat plate, it is particularly effective for removing paint from detail work because the nozzle can be directed at curved and intricate surfaces. Its use is thus more limited than the heat plate, and most successfully used in conjunction *with* the heat plate. For example, it takes about two to three hours to strip a paneled door with a heat gun, but if used in combination with a heat plate for the large, flat area, the time can usually be cut in half. Although a heat gun seldom scorches wood, it can cause fires (like the blow torch) if aimed at the dusty cavity between the exterior sheathing and siding and interior lath and plaster. A fire may smolder for hours before flames break through to the surface. Therefore, this thermal device is best suited for use on solid decorative elements, such as molding, balusters, fretwork, or "gingerbread."

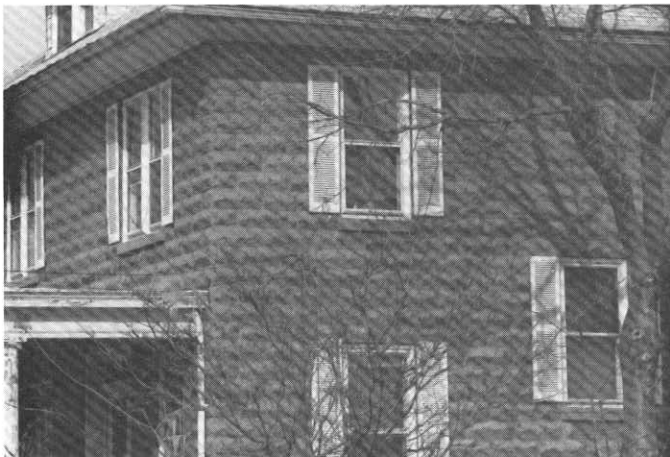
*Illus. 3. Casting concrete to represent quarried stone was a popular late 19th-century technique seen in this circa 1910 mail-order house. While most components were delivered by rail, the foundations and exterior masonry were completed by local craftsmen. Photo: Sharon C. Park, AIA.*

expensive quarrying and shipping costs, and were versatile in representing either ornately carved blocks, plain wall stones or rough cut textured surfaces. The end result depended on the type of patterned or textured mold used and was particularly popular in conjunction with mail order houses (see illus. 3). Later, panels of cementitious perma-stone or formstone and less expensive asphalt and sheet metal panels were used to imitate brick or stone.

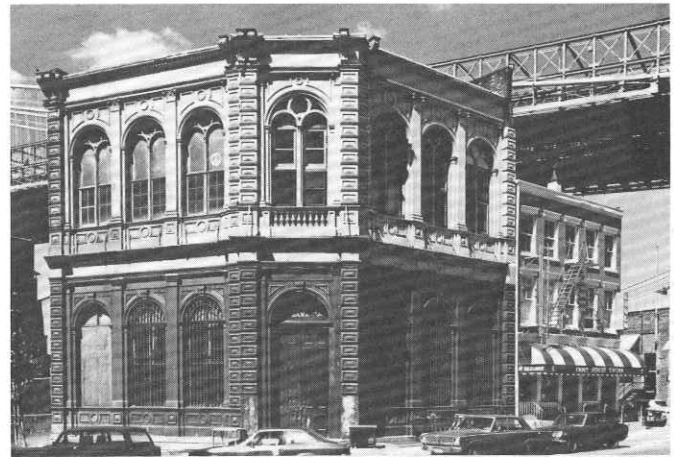
*Illus. 4. The 19th-century also produced a variety of metal products used in imitation of other materials. In this case, the entire exterior of the Long Island Safety Deposit Company is cast-iron representing stone. Photo: Becket Logan, Friends of Cast Iron Architecture.*

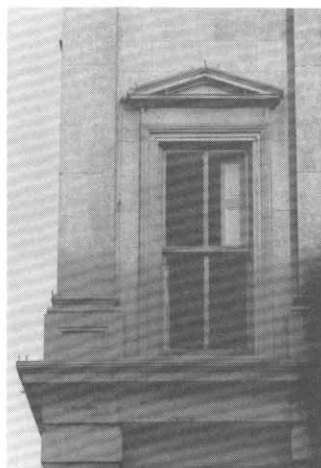
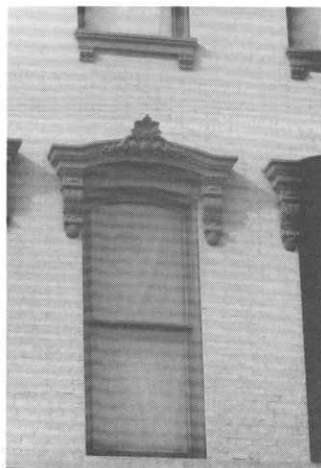
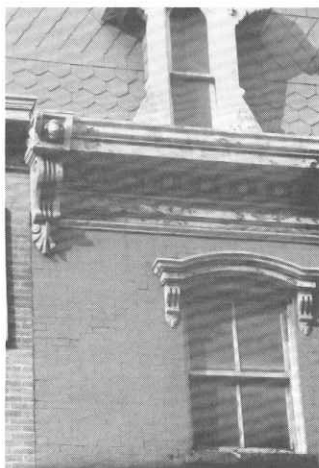
*Illus. 5. The four historic examples of various window hoods shown are: (a) stone; (b) cast stone; (c) cast-iron; and (d) sheet metal. The criteria for selecting substitute materials today (availability, quality, delivery dates, cost) are not much different from the past. Photo: Sharon C. Park, AIA.*

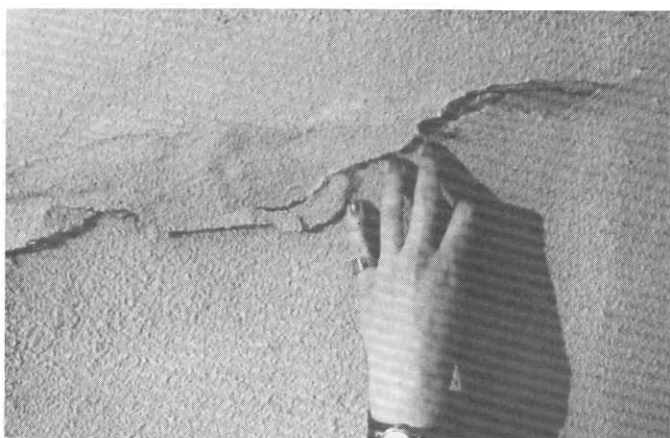
*Illus. 6. Substitute materials should never be considered as a cosmetic cover-up for they can cause great physical damage and can alter the appearance of historic buildings. For example, a fiberglass coating was used at Rancho de Taos, NM, in place of the historic adobe coating which had deteriorated. The waterproof coating sealed moisture in the walls and caused the spalling shown. It was subsequently removed and the walls were properly repaired with adobe. Photo: Lee H. Nelson, FAIA.*

Because the overzealous use of substitute materials can greatly impair the historic character of a historic structure, all preservation options should be explored thoroughly before substitute materials are used. It is important to remember that the purpose of repairing damaged features and of replacing lost and irreparably damaged ones is both to match visually what was there and to cause no further deterioration. For these reasons it is not appropriate to cover up historic materials with synthetic materials that will alter the appearance, proportions and details of a historic building and that will conceal future deterioration (see illus. 6).

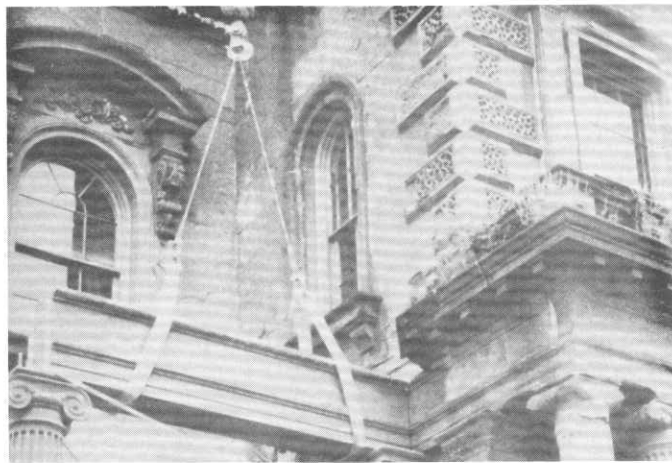
*Illus. 9. Simple solutions should not be overlooked when materials are no longer available. In the case of the Morse-Libby Mansion (1859), Portland, ME, the deteriorated brownstone porch beam was replaced with a carved wooden beam painted with sand impregnated paint. Photo: Stephen Sewall.*

as a replacement section, achieved using readily available traditional materials, conventional tools and work skills. (see illus. 9). Simple solutions should not be overlooked.

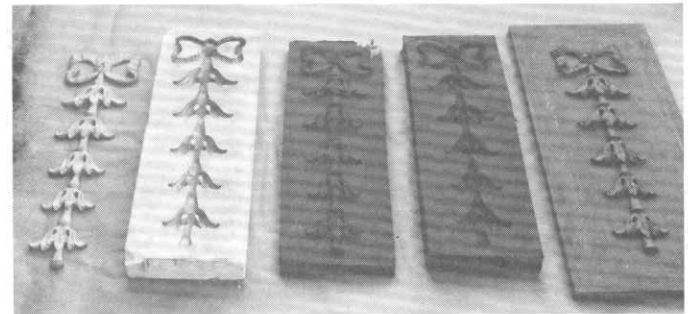
*Illus. 10. The use of substitute materials is not necessarily cheaper or easier than using the original materials. The complex process of fabricating the polyester bronze reproduction pieces of the gilded wood molding for the clockcase at Independence Hall required talented artisans and substantial mold-making time. From left to right is the final molded polyester bronze detail; the plaster casting mold; the positive and negative interim neoprene rubber molds; and the expertly carved wooden master. Photo: Courtesy of Independence National Historical Park.*

aluminum, cast stone, fiberglass, polymer concretes, glass fiber reinforced concretes and terra cotta. Mold making and casting takes skill and craftsmen who can undertake this work are available. (see illus. 10, 11). Efforts should always be made, prior to replacement, to seek out artisans who might be able to repair ornamental elements and thereby save the historic features in place.

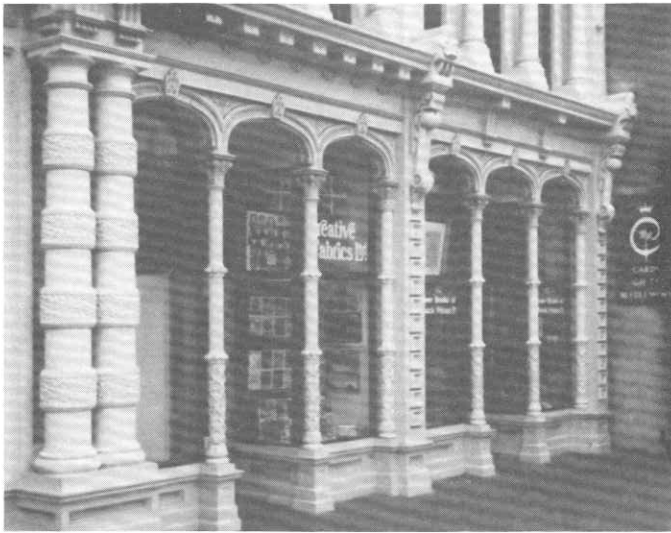
*Illus. 11. The unavailability of historic craft techniques is another reason to consider substitute materials. The original first floor cast iron front of the Grand Opera House, Wilmington, DE, was missing; the expeditious reproduction in cast aluminum was possible because artisans working in this medium were available. Photo: John G. Waite.*

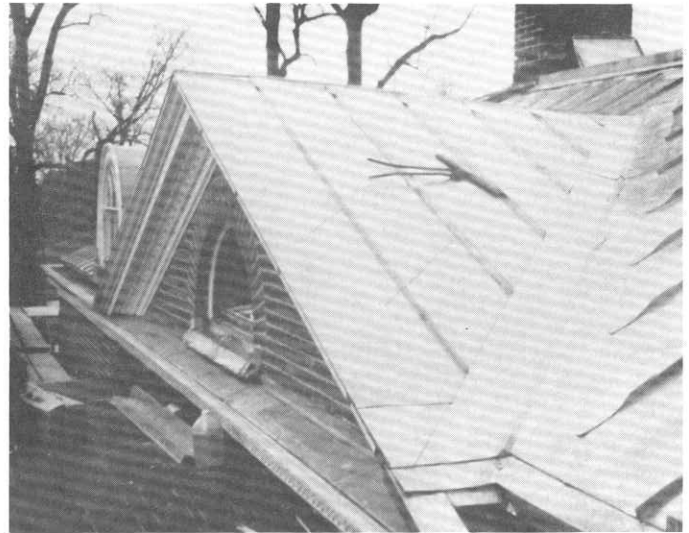
*Illus. 12. Substitute materials may be considered when the original materials have not performed well. For example, early sheet metals used for roofing, such as tinplate, were reasonably durable, but the modern equivalent, terne-coated steel, is subject to corrosion once the thin tin plating is damaged. Terne-coated stainless steel or lead-coated copper (shown here) are now used as substitutes. Photo: John G. Waite.*

**3. Poor original building materials.** Some historic building materials were of inherently poor quality or their modern counterparts are inferior. In addition, some materials were naturally incompatible with other materials on the building, causing staining or galvanic corrosion. Examples of poor quality materials were the very soft sandstones which eroded quickly. An example of poor quality modern replacement material is the tin coated steel roofing which is much less durable than the historic tin or terne iron which is no longer available. In some cases, more durable natural stones or precast concrete might be available as substitutes for the soft stones and modern terne-coated stainless steel or lead-coated copper might produce a more durable yet visually compatible replacement roofing (see illus. 12).

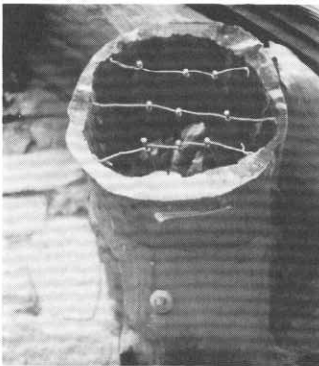
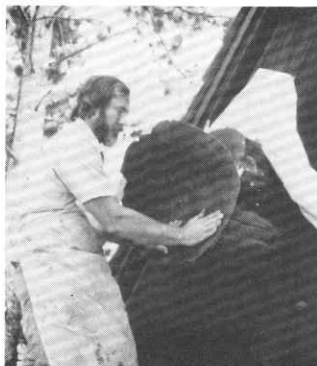
*Illus. 17. Care must be taken to ensure that the replacement materials will work within a predesigned system. At the Norris Museum, Yellowstone National Park, the 12-inch diameter log rafters, part of an intricate truss system, had rotted at the inner core from the exposed ends back to a depth of 48 inches. The exterior wooden shells remained intact. Fiberglass rods (left photo) and specially formulated structural epoxy were used to fill the cleaned out cores and a cast epoxy wafer end with all the detail of the original wood graining was laminated onto the log end (right photo). This treatment preserved the original feature with a combination of repair and replacement using substitute materials as part of a well thought out system. Photos: Courtesy of Harrison Goodall.*

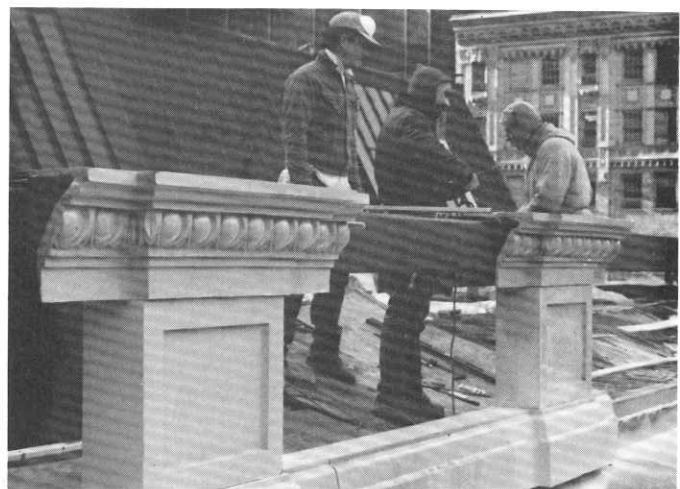
*Illus. 18. Substitute materials must be properly installed to allow for expansion, contraction, and structural security. The new balustrade (a polymer concrete modified with glass fibers) at Carnegie Hall, New York City, was installed with steel structural supports to allow window-washing equipment to be suspended securely. In addition, the formulation of this predominantly epoxy material allowed for the natural expansion and contraction within the predesigned joints. Photo: Courtesy of MJM Studios.*

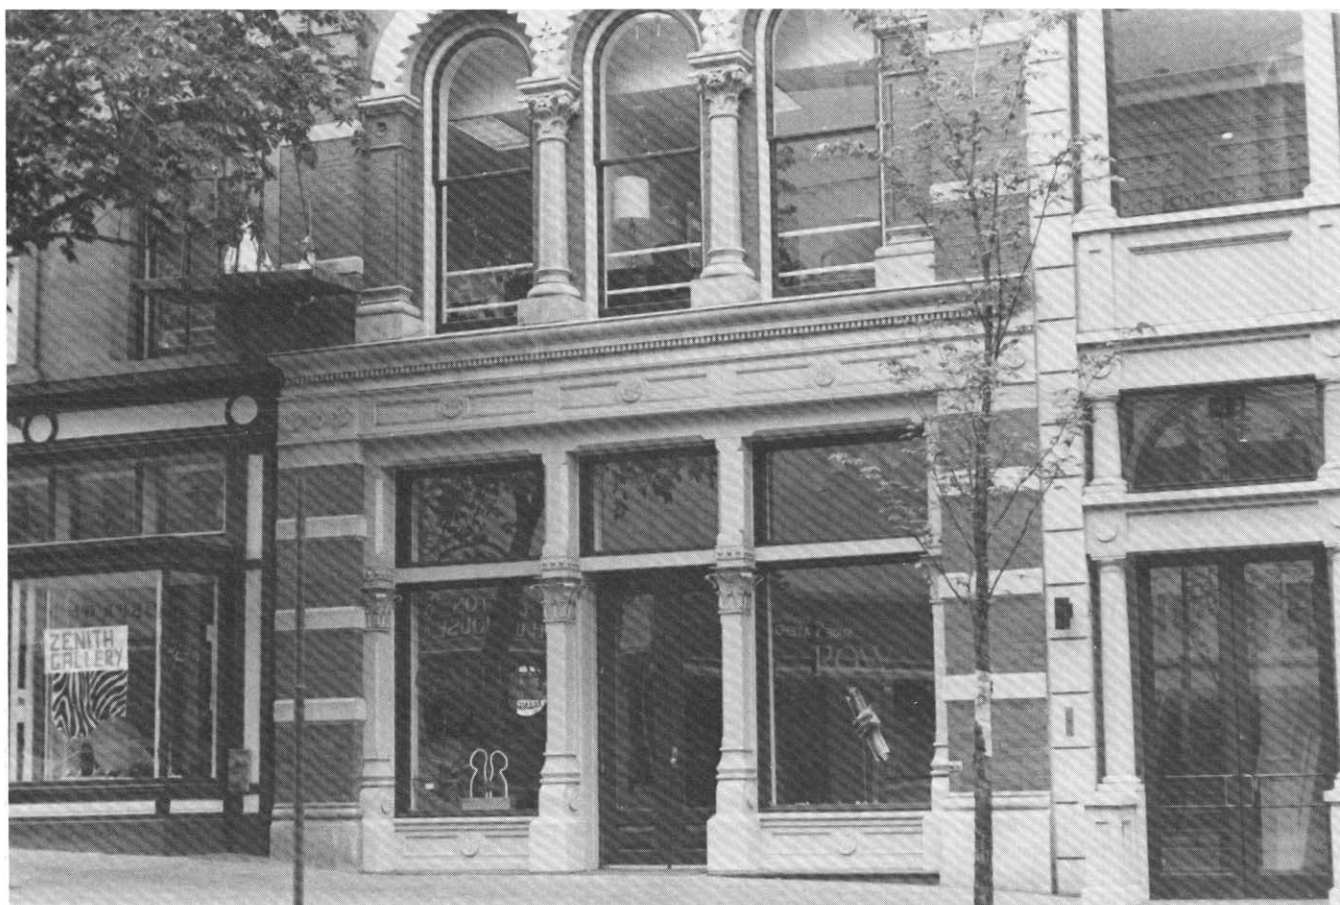
*The new cast aluminum storefront replaced the lost 19th-century cast-iron original. Photo: Sharon C. Park, AIA.*

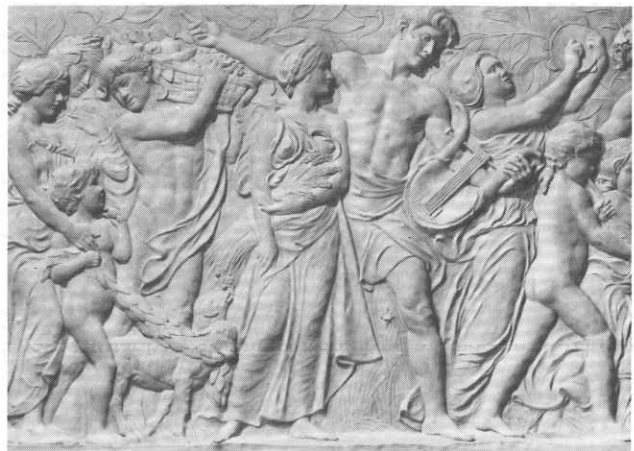
*This glass fiber reinforced concrete sculptural wall panel will replace the seriously damaged resin and plaster original. A finely textured surface was achieved by spraying the GFRC mix into molds that were created from the historic panel and resculpted based on historic photographs. Photo: Courtesy of MJM Studios.*
